DESIGN, FABRICATION AND HYDROTESTING
OF A 120-INCH DIAMETER PRESSURE VESSEL
USING 18 PERCENT NICKEL
MARAGING STEEL

Research Contract Status Report No. 8

LOCKHEED PROPULSION COMPANY
P. O. Box 111
Redlands, California

METALLURGICAL ANALYSIS OF FRACTURED CLOSURE PLATE
OF THE 120-INCH MARAGING STEEL PROTOTYPE VESSEL

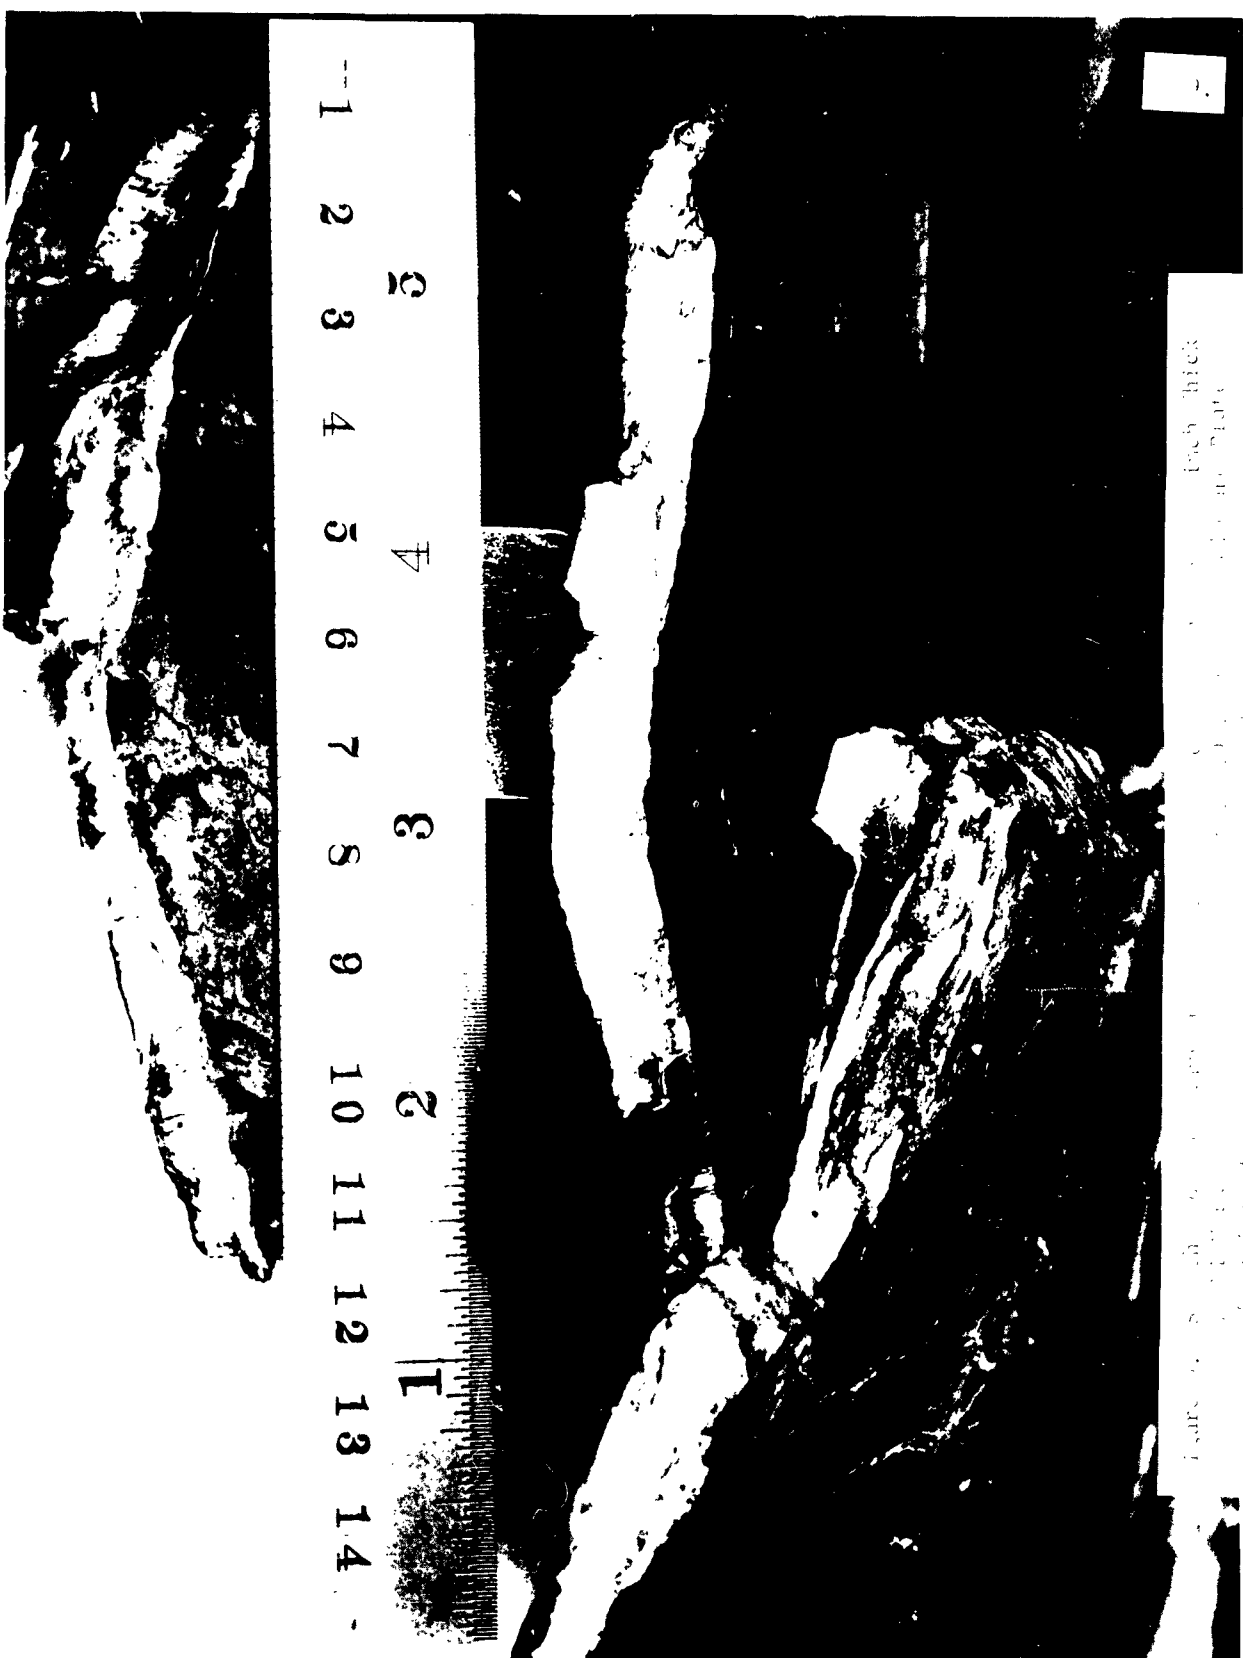
Figure 4. Varied Fracture Textures Seen in the 5/8 inch Thick 18Ni Maraging Steel plate Used in the 120 inch Vessel Hydrotest Closure Plate

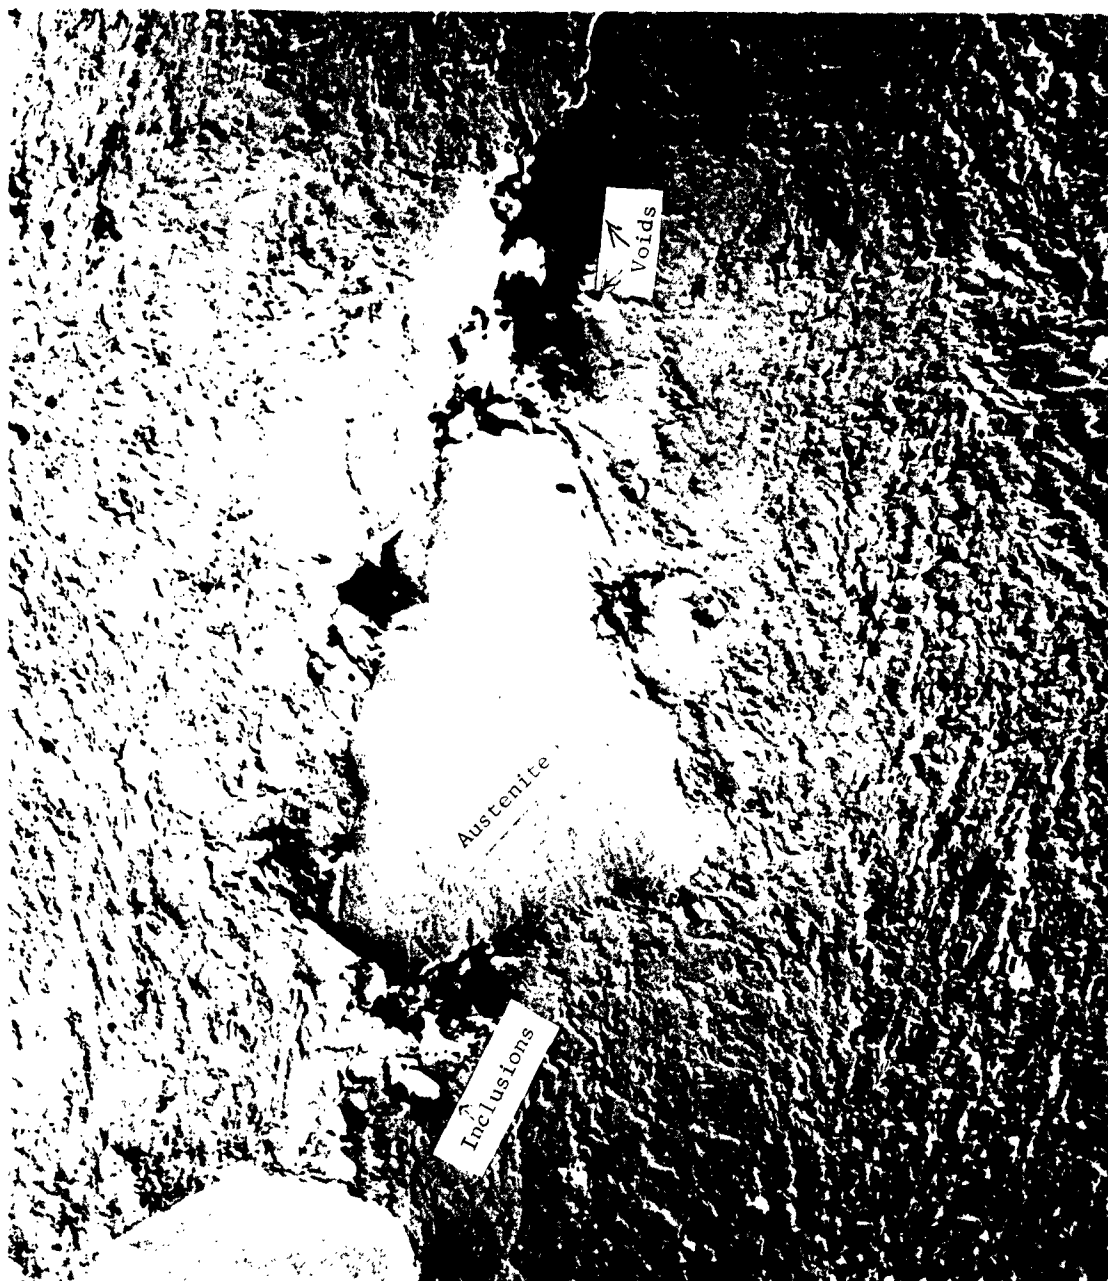
Typical electron microstructures seen in selected areas of the plate to forging weld transition section of the closure plate are as depicted in Figures 39 through 46. Pertinent explanations of these electron micrographs and identification of the microconstituents observed are given at the bottom of each picture. The complexity of the microstructure in the banded areas is clearly evident. Unique identification of the band microconstituents must await further studies through the use of an electron microprobe analyzer. Interpretation of similar microstructures as provided by earlier investigations, (1, 2)* has been freely used in the preliminary identification of microconstituents in subject electron micrographs.

Figure 40. Electron Micrographs Showing Inclusions, Voids and Austenite in Weld-Banded Plate Interface
6,900X

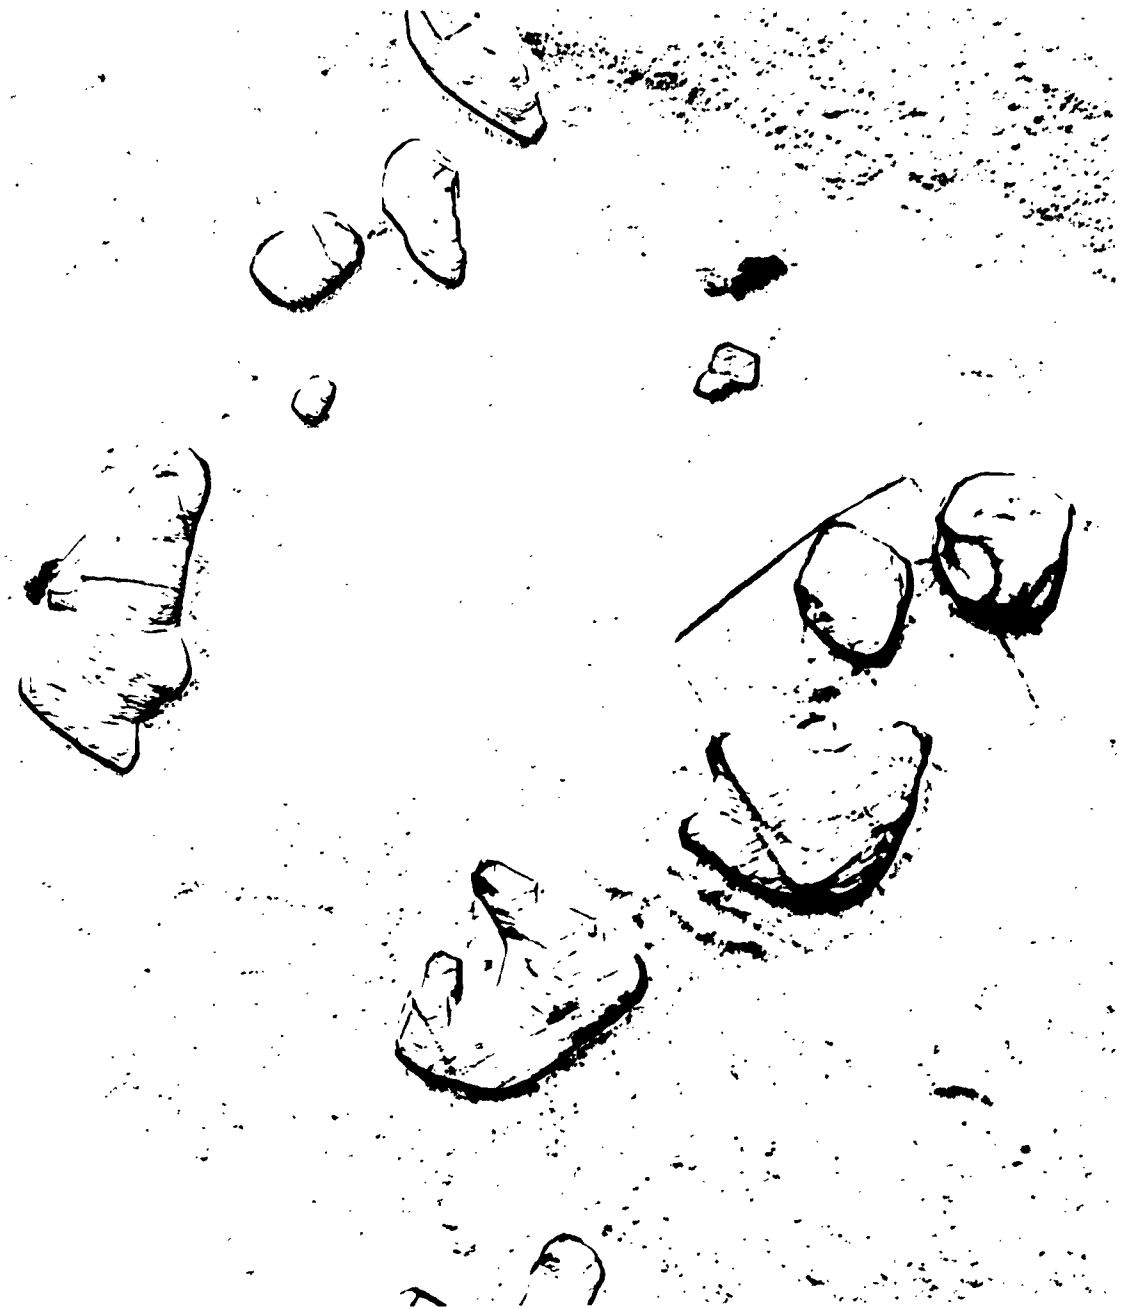
Figure 45. Typical Electron Microstructure Showing Clam Shell Shaped Titanium Carbides or Nitrides at Forging-Weld Fusion Zone. 120 inch Maraging 18Ni Steel Vessel Closure Plate
24,000X Plastic Replica

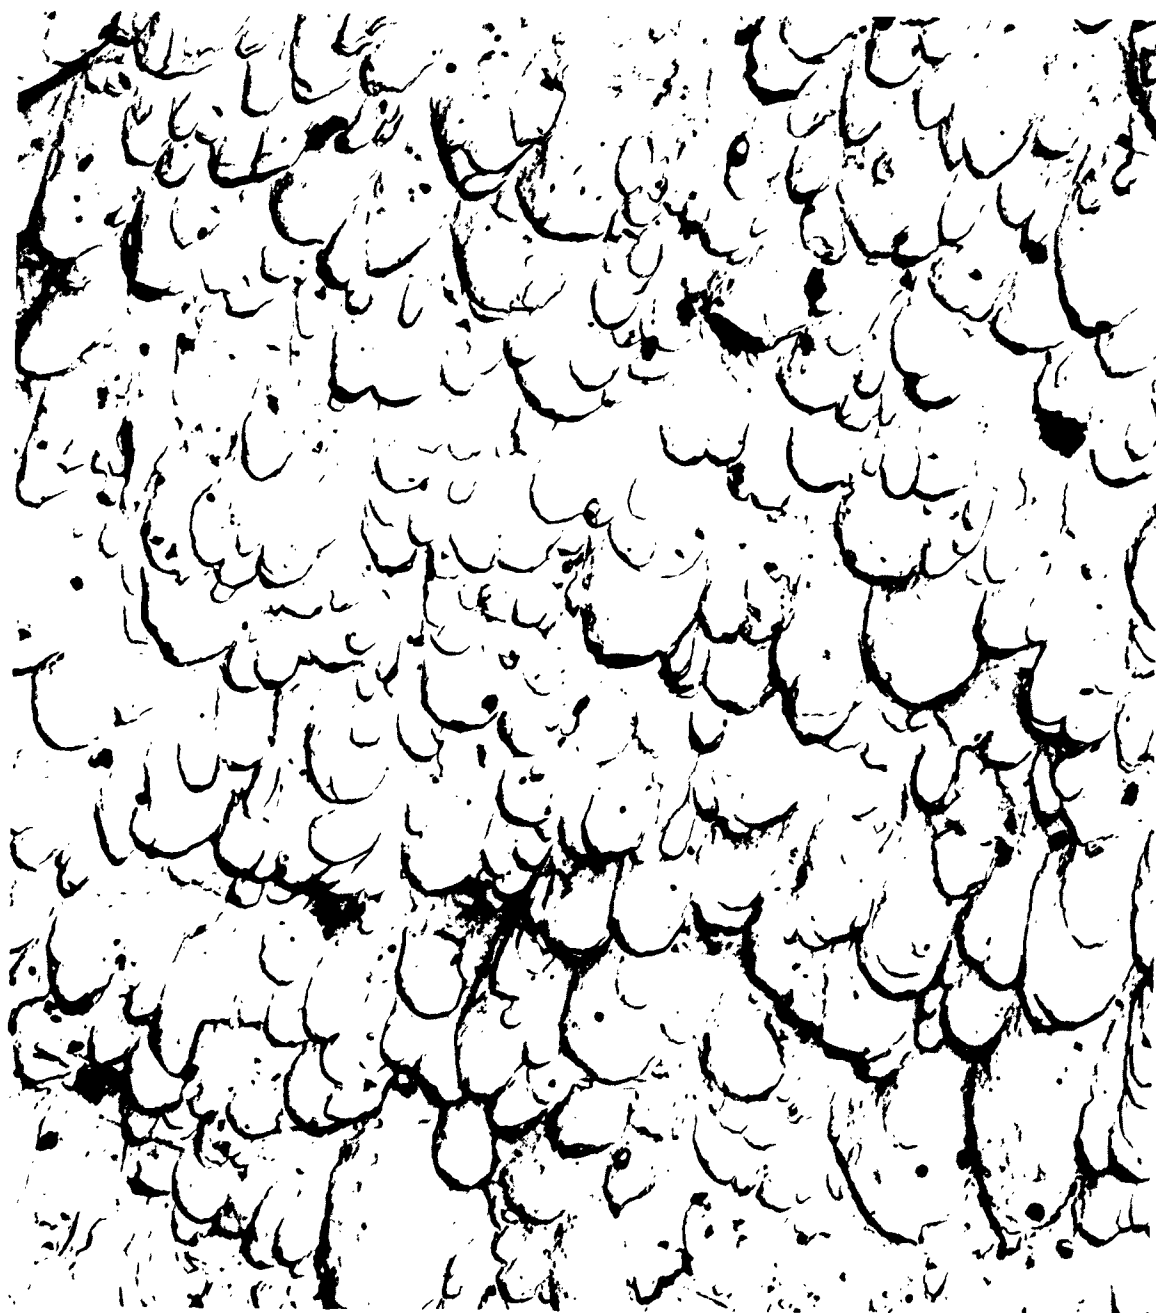
Figure 4/. Electron Fractograph Showing Ductile Fracture Surfaces in the Forging
Consisting of Nearly Elliptical Domains - 120 inch Maraging 18Ni Steel
Vessel Closure Plate
12,000X

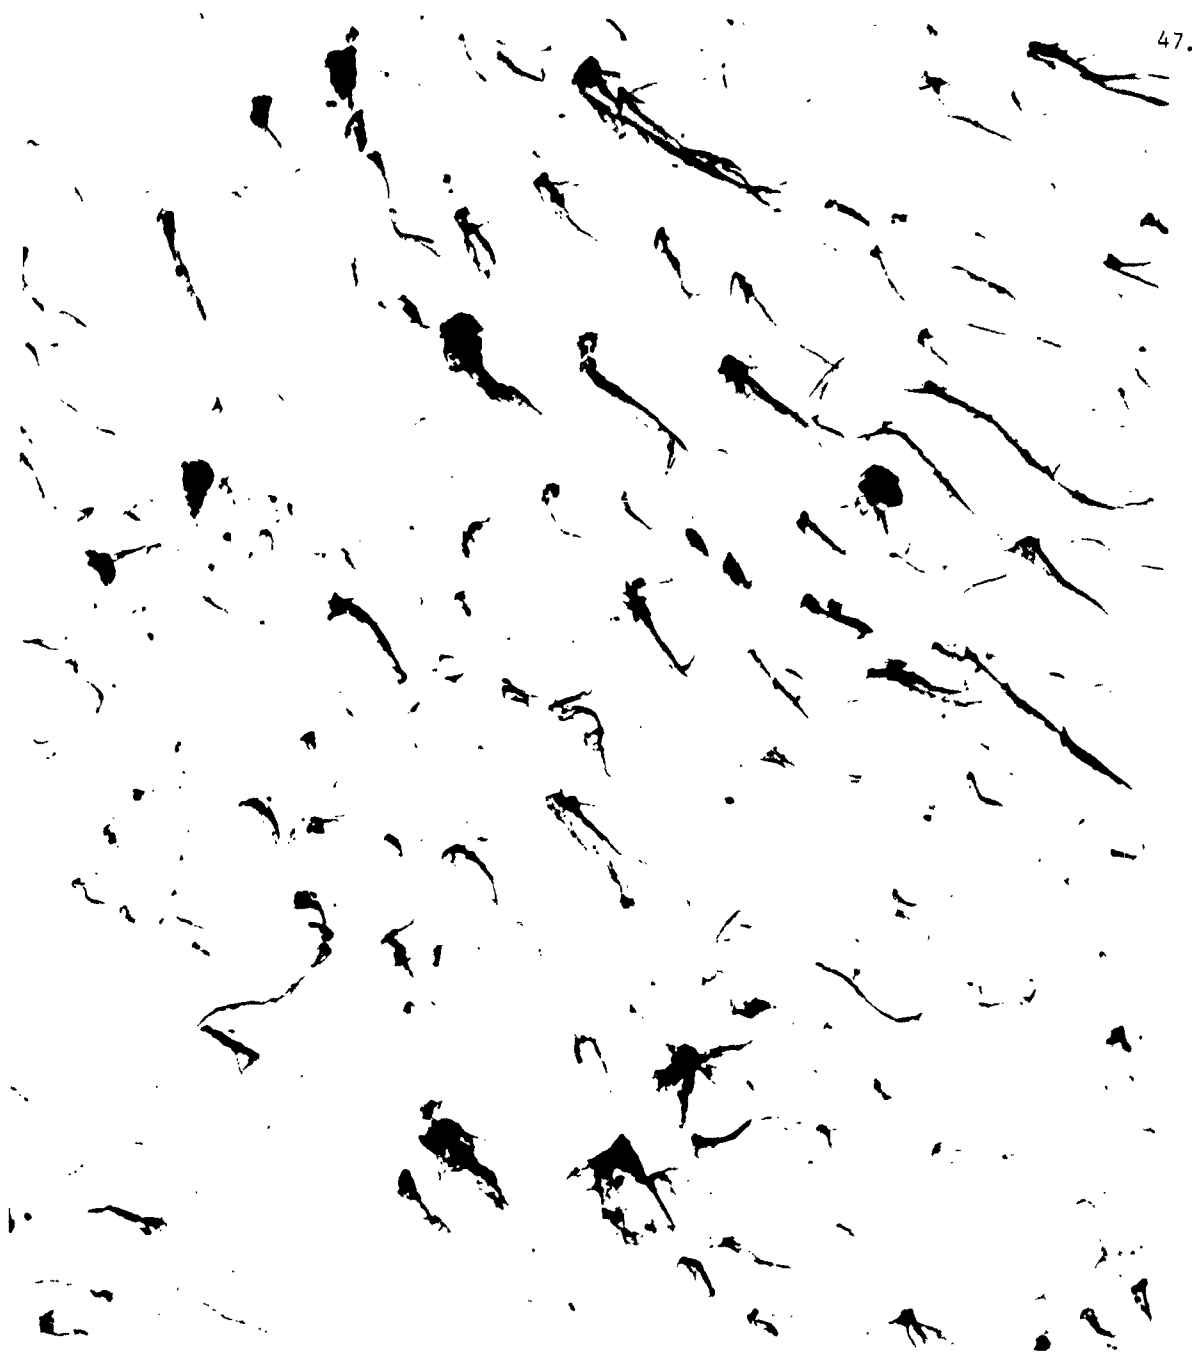
Electron fractographs obtained from fracture surface adjacent to the weld joining the plate to the forging (location) indicates severe plastic deformation and long shear lips as indicated in Figure 48. To the naked eye, this surface appears quite shiny and misleading. Except for the electron fractographic evidence, one could argue on this as brittle type fracture. Fracture surface in the weld per se appears as shown in Figure 49. The dark appearing long laths are probably titanium carbo-nitrides or titanium carbides. The welds are replete with respect to these microconstituents.

Figure 49. Electron Fractograph of Fracture Surfaces in the Weld (120 inch
Maraging Steel Vessel Closure Plate) Dark Appearing Particles are
Probably Titanium Carbides or Nitrides
12,000X
